This detail exhibits rebuild strategies with hand pressed architectural terra cotta (TC). Other options may be appropriate. It is best to consult a professional team of engineers, architects, and architectural conservators when crafting a repair or rebuild scenario for historic architectural TC.

Terra cotta, Pressed, Hand pressed, Rebuild, Sill, Mullion, Brick, Restoration, Anchor, Repair, Window, Flashing, 10.030.0432

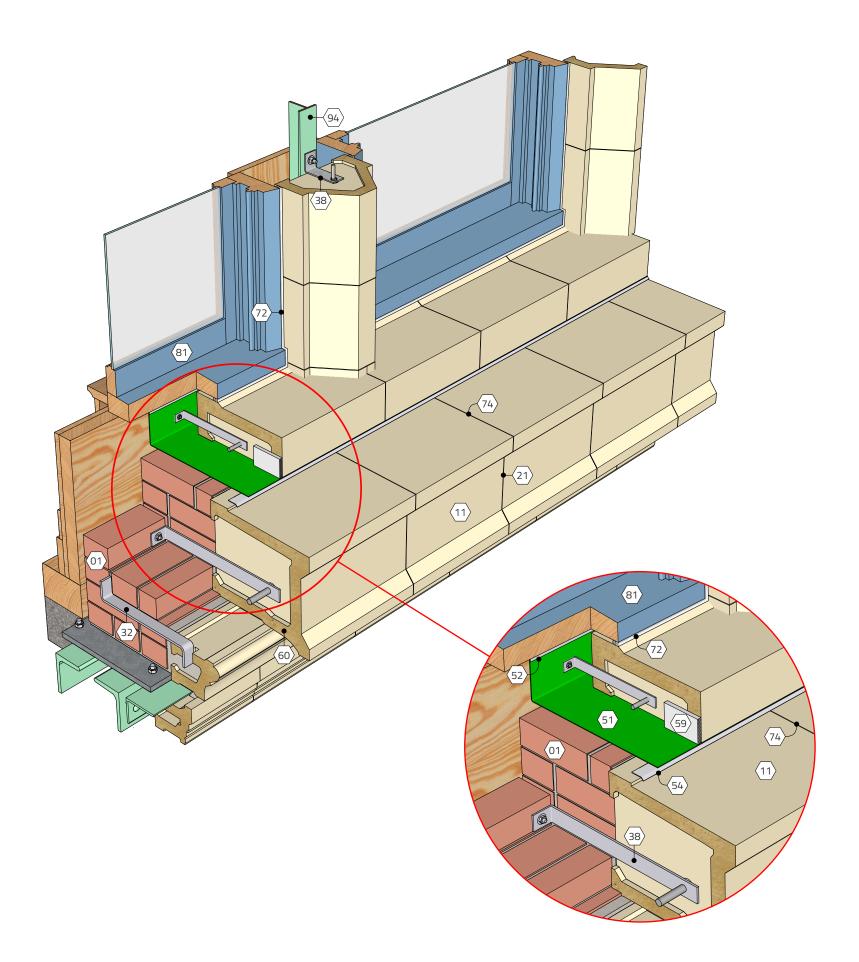
- (E) Masonry backup, multiwythe construction
- Architectural terra cotta, hand pressed
- (21) Mortar
- 32 Stainless steel Z anchor
- Stainless steel strap and pin anchor
- 51 Flashing system with end dams as required
- Termination bar with continuous sealant
- Stainless steel drip edge; seal and adhere to substrate
- 59 Weep vent
- 60 Weep hole at underside of each overhanging TC unit
- $\langle 72 \rangle$ Sealant and backer rod
- Sealant or lead T-caps at all horizontal skyward-facing joints
- (75) Plastic setting shims as required
- (81) (E) Window assembly
- (94) (E) Structural steel treated with corrosion-inhibiting coating

This drawing references Sill and Mullion - Original Plate 32.

Where anchors penetrate flashing, seal with compatible sealant.
